**SCROOBY'S LABORATORY SERVICE (Pty) Ltd***Spectrographic, Chemical and Mechanical Testing of Materials*

**CERTIFICATE OF TEST**REFERENCE No: **34965*****SALT SPRAY TESTING OF PLATES*****INTRODUCTION**

Plate – JP357536D2-ZAM310 S350GD

Half pipe section

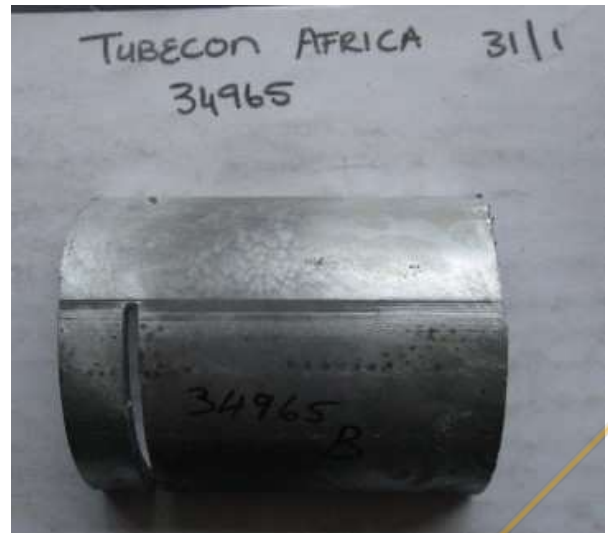
**Samples as received**

The components were identified as;

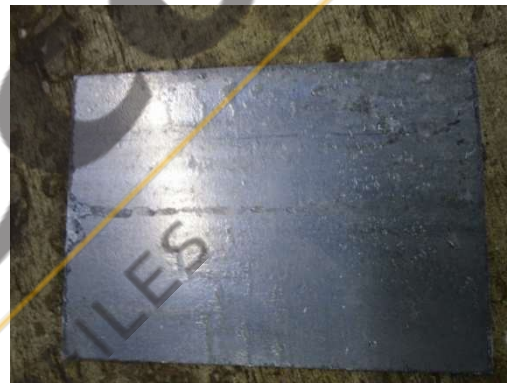
After 24 hours white rust was observed.

After 216 hours, only white rust was observed at random spots on the surface of the plate.

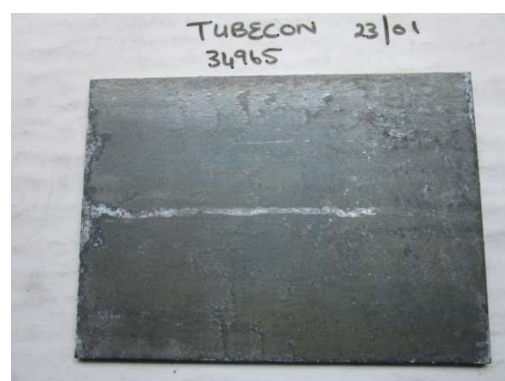
After 500 hours exposure the component was removed from the chamber, rinsed with warm water and immediately dried. When inspected by the naked eye, there are no signs of pitting, or base metal ferrous corrosion.

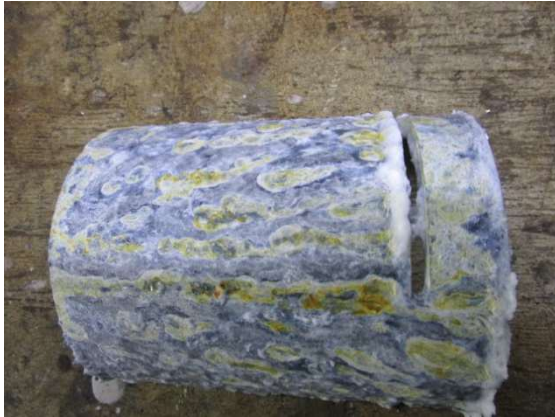
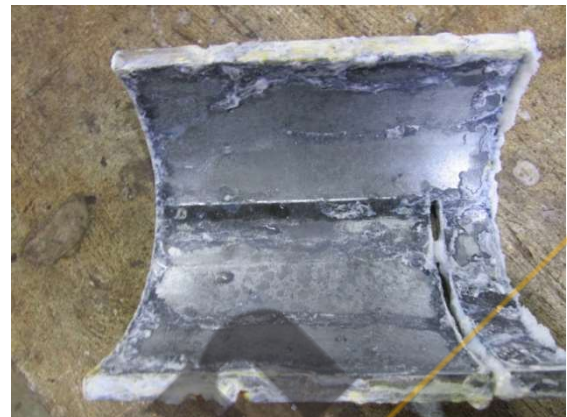
After 24 hours white rust was observed.

After 48 hours, small isolated spots of red ferrous rust were observed.

After 216 hours, white rust continues to intensify, red rust develops on the outer surface of the pipe.

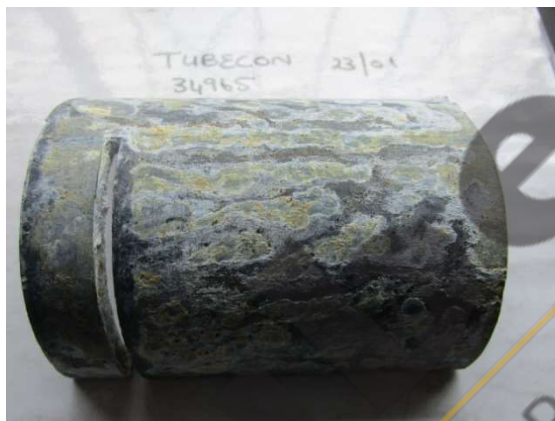
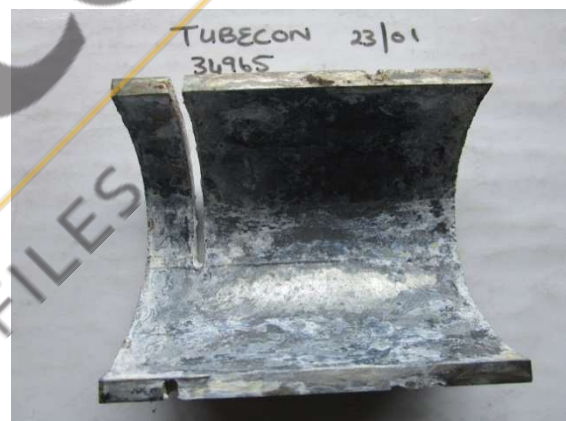
After 500 hours exposure the component was removed from the chamber, rinsed with warm water and immediately dried. When inspected by the naked eye, there are no signs of pitting, base metal ferrous corrosion is observed more on the outer surface than on the inner surface.
